Service Bulletin 4812 715 40175

TITLE: Condensation water of Full glass ventilated door dropping on furniture

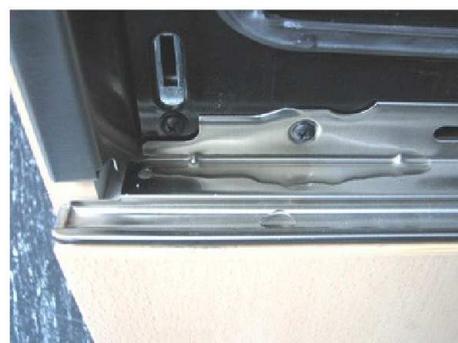
4812 460 68639	Inox
4812 460 68641	Black
4812 460 49894	White

During cooking of humid food there could occur condensation on the inner glass of the oven door. Normally this water is collected in the trim under the door. If the amount of water during normal cooking is too much, the trim can be changed with a bigger bottom trim to avoid water dropping on the furniture.

Mount a bigger bottom trim under the door to collect the condensate and protect the furniture

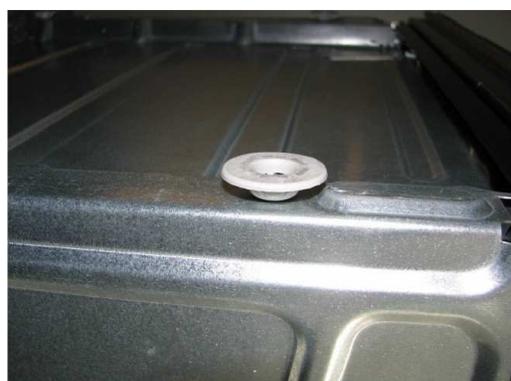
foot under oven

After installing the new bottom trim the gap between trim and furniture could be not big enough, door is blocked or furniture scratched. In these few cases feet can be mounted under the oven to lift up the appliance.

Service Kit **4812 310 39226**: consisting 4 feet and 4 screws

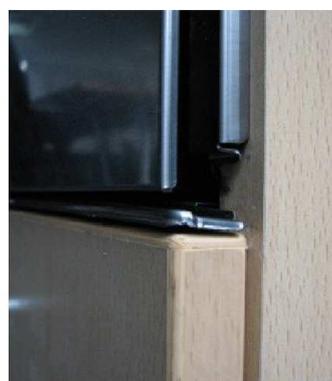
bottom trim too near to furniture
